RESEARCH MEMORANDUM

INVESTIGATION OF BLADE FAILURES IN A J34, ELEVEN-STAGE
AXIAL-FLOW COMPRESSOR

By Howard F. Calvert, André J. Meyer, Jr. and C. Robert Morse

Lewis Flight Propulsion Laboratory
Cleveland, Ohio

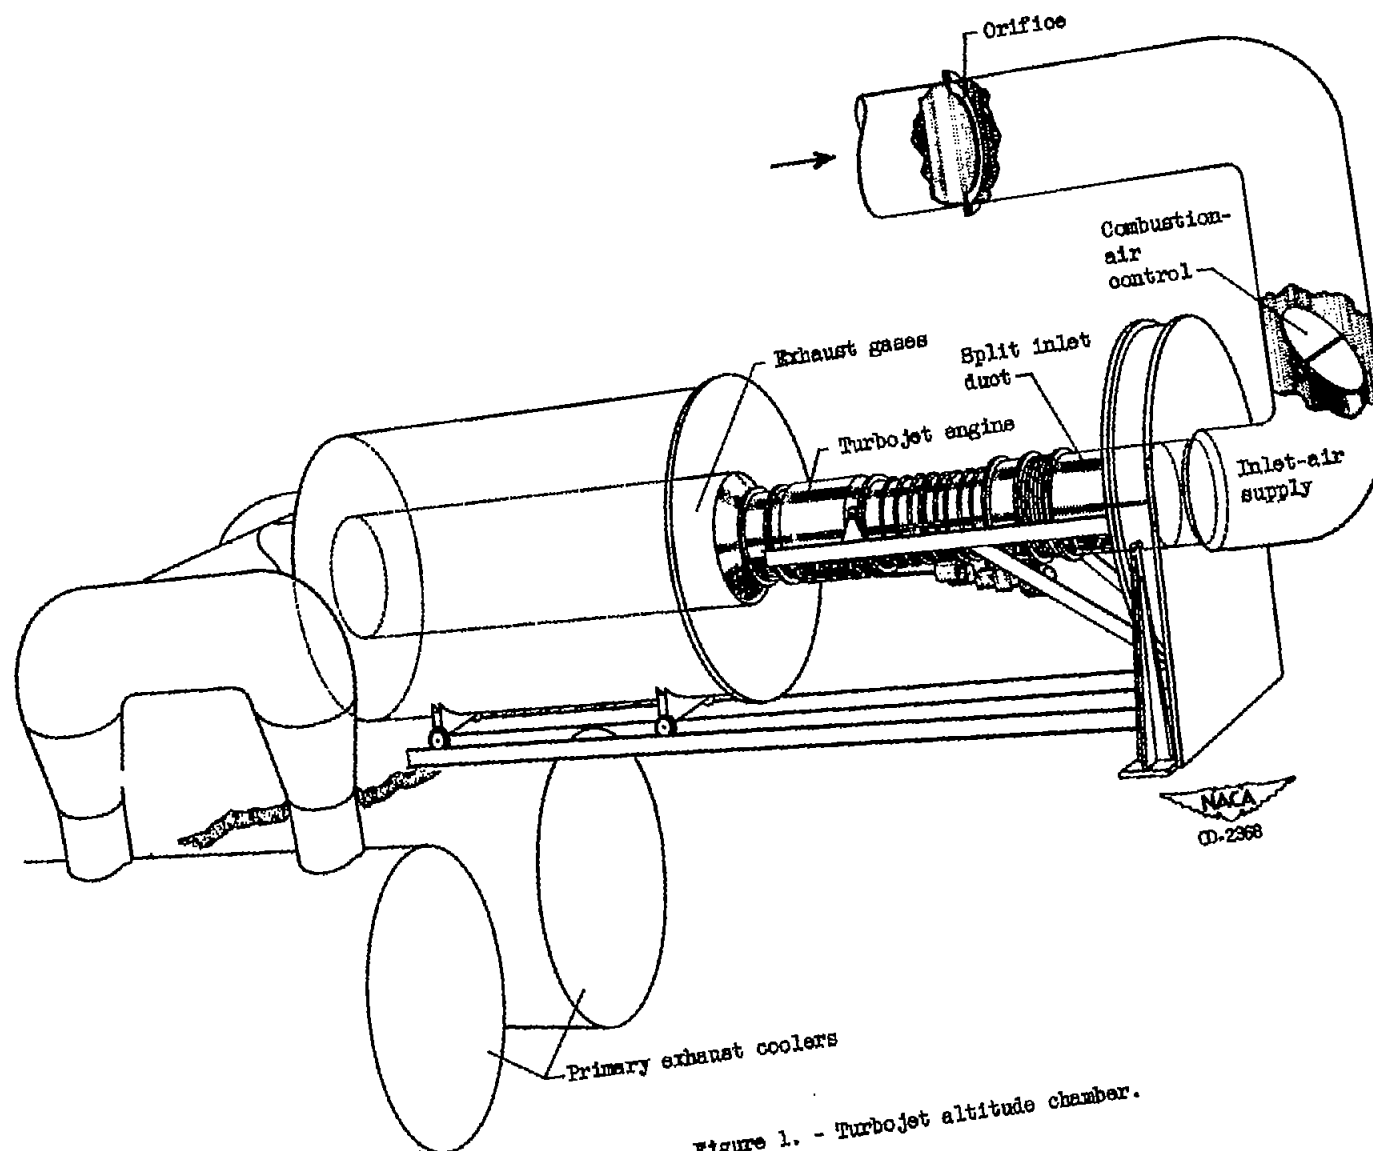
Figure 1. - Turbojet altitude chamber.

The engine was operated throughout the normal speed range of 5000 to 12,500 rpm in order to observe all blade vibrations present. The investigation was conducted with the turbojet engine operating in two different test cells. First, the engine was operated in a turbojet altitude chamber (fig. 1) where the air supply and exhaust were connected to the laboratory systems. Second, the engine was operated in a sea-level test stand where the air supply was taken from the surrounding atmosphere and exhausted through a muffler to the atmosphere. All engine parts were fabricated by the engine manufacturer and sent to the Lewis laboratory.

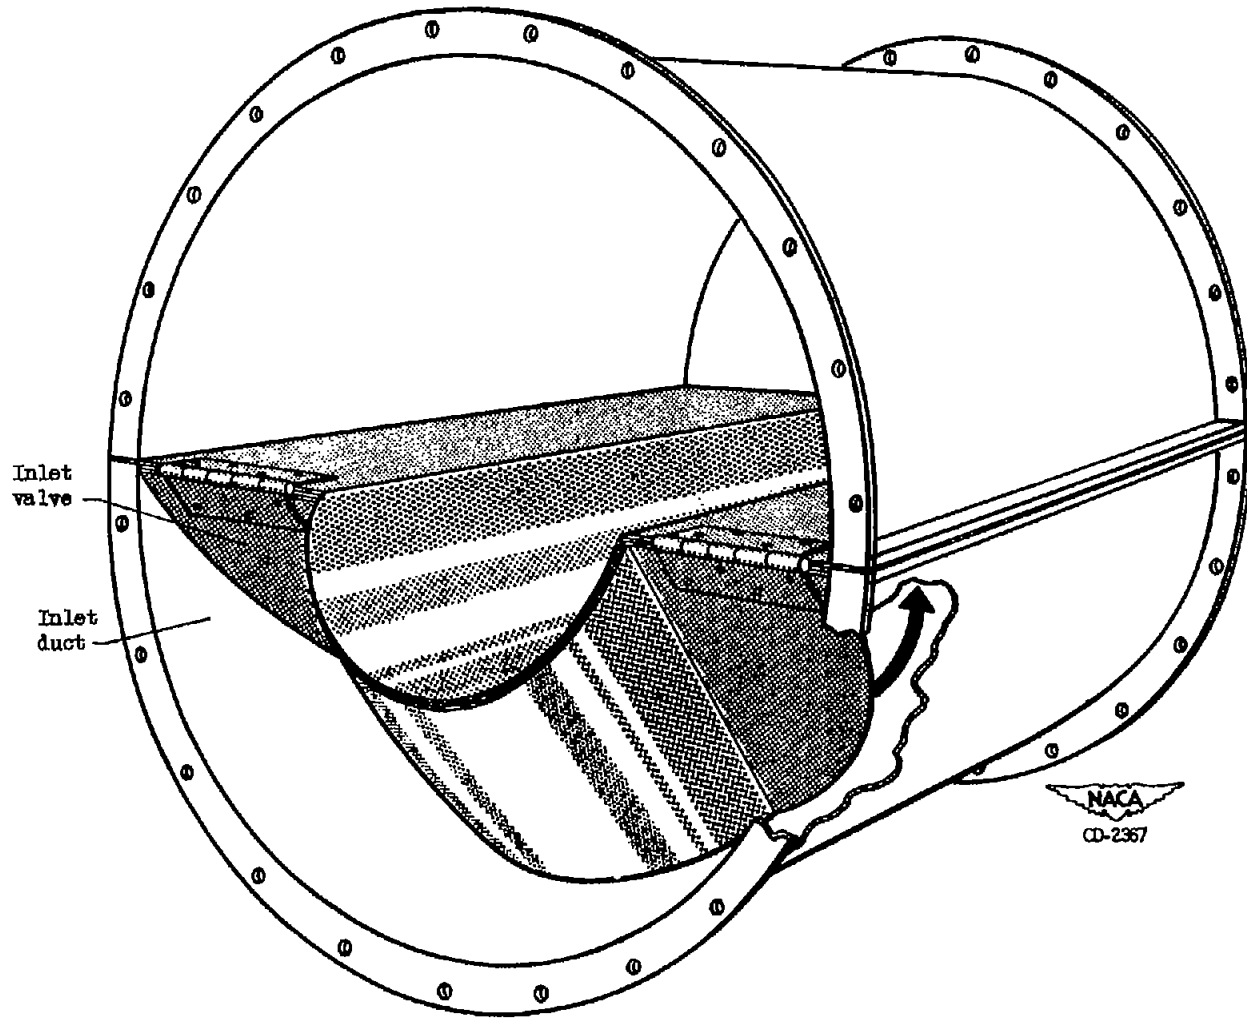
Figure 2. - Split inlet duct and inlet valve.

Inlet valve. - A special valve assembly (fig. 2) was fabricated to control the air flow to one-half of the compressor inlet from approximately zero to full flow. This valve simulated possible uneven air-flow conditions of the two-duct inlet-air supply system used in many aircraft and was used to determine the effect of flow pattern on vibration.

Inlet duct. - The section of inlet ducting containing the special valve was fabricated in two parts (fig. 2). The top half of the duct and the special valve were removed, and the engine was operated throughout the critical speed range. With the duct open the engine was receiving its air from the test cell. This procedure was carried out to determine the effect of the laboratory inlet piping on the vibration.

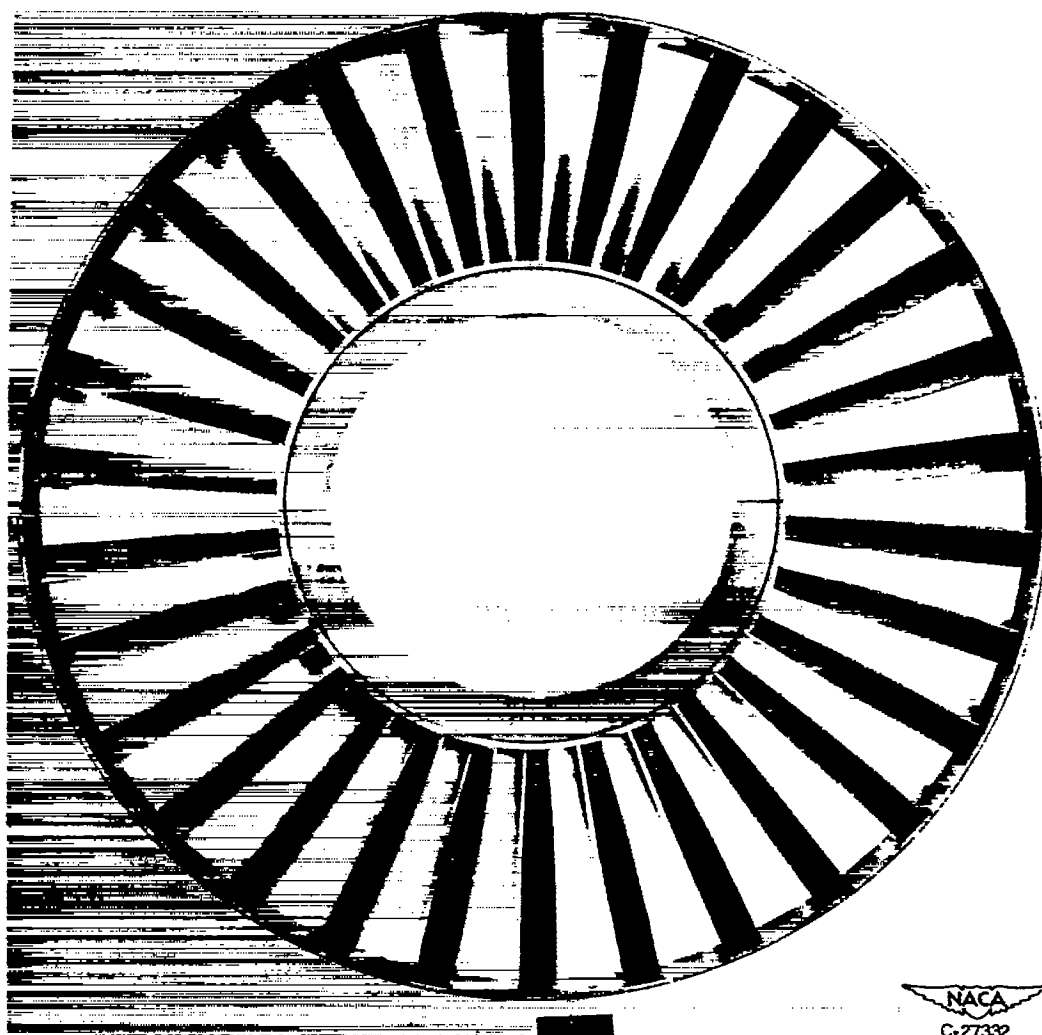
Figure 3. - Second-stage stator vane.

Stator blades. - Twisting or changing the angle of incidence of stator or rotor blades is a common standard means of attempting to solve such air-flow problems as compressor stall. A series of second-stage stators were fabricated by the engine manufacturer with various angles of incidence (fig. 3). These angles are shown in table I.

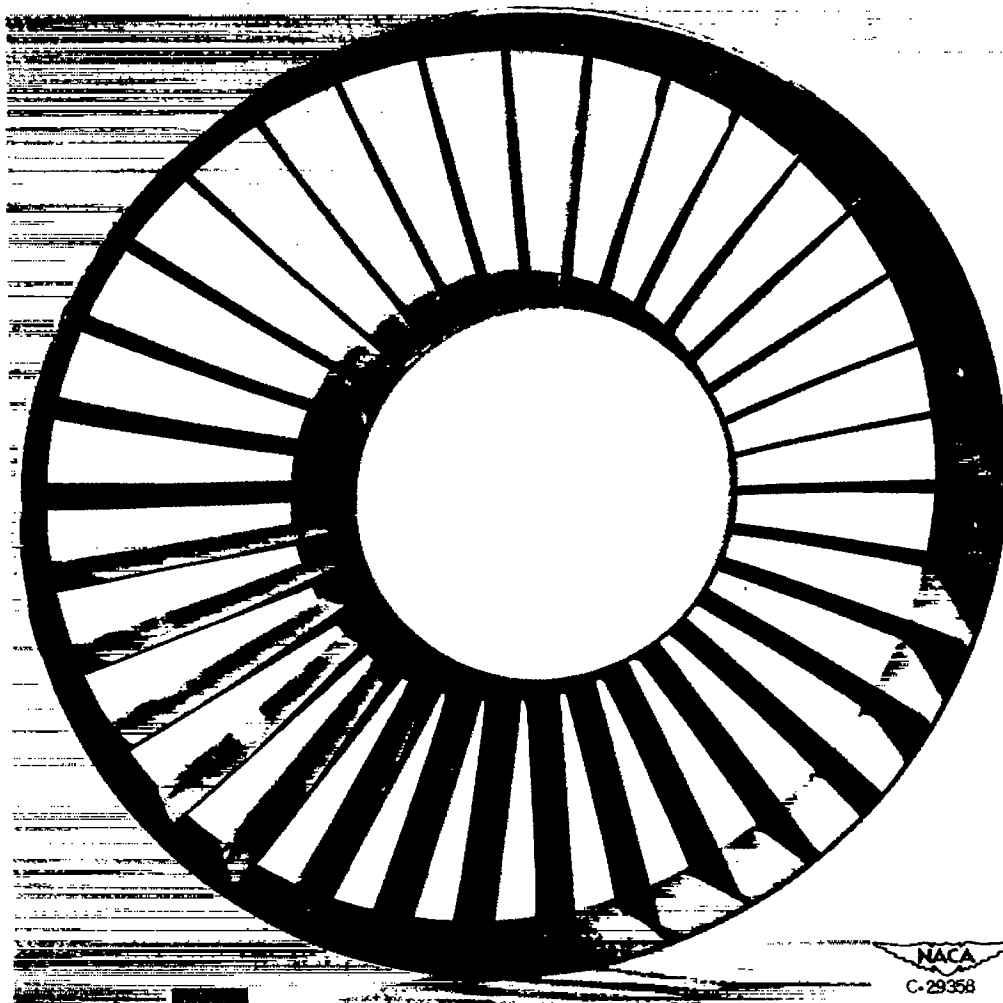
Figure 4. - Inlet guide vane.

Inlet guide vanes. - A new inlet-guide-vane assembly (fig. 4) was fabricated by the manufacturer with a decreased angle of incidence of the vanes, which resulted in a 4-percent increase in the inlet flow area. This new inlet was operated with all the second-stage stators listed in table I.

Inlet guide vanes. - It was decided to investigate the effect of opening the compressor-inlet flow area to increase the weight flow and engine thrust. The manufacturer supplied new inlet guide vanes (fig. 4) with an increase in flow area of approximately 4 percent. The vanes were installed in the engine and the engine operated throughout the complete speed range. The operation with the new inlet guide vanes and standard second-stage stators indicated that the serious third-stage vibrations had been eliminated and no new vibration introduced. A check of the engine thrust at military take-off showed that the change in inlet guide vanes had increased the thrust approximately 4 percent, or an increase of $7\frac{1}{2}$ percent over the operation with the 9° -closed stators.

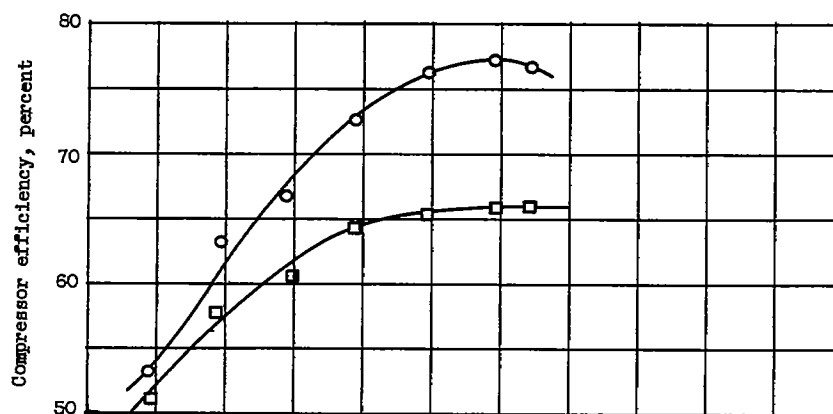
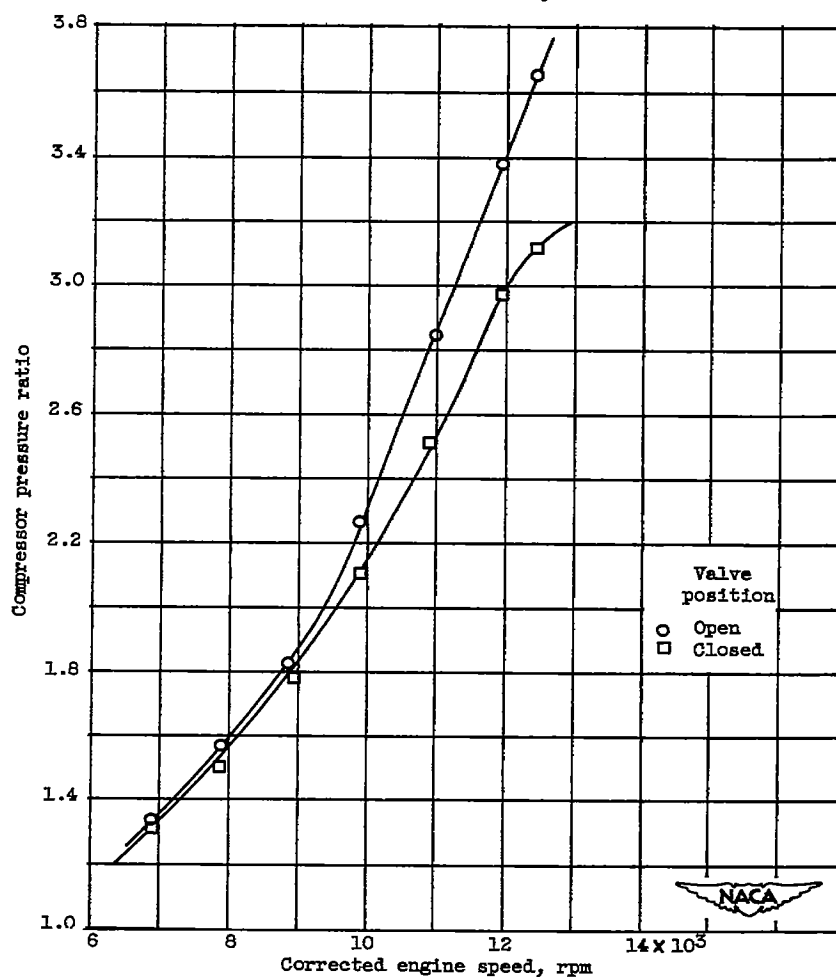
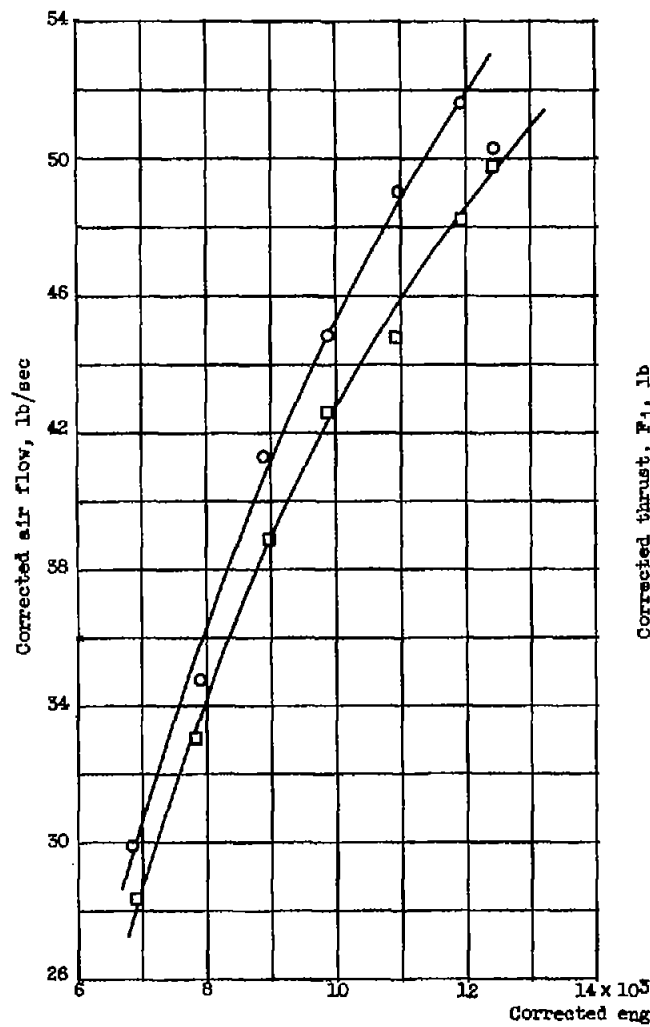
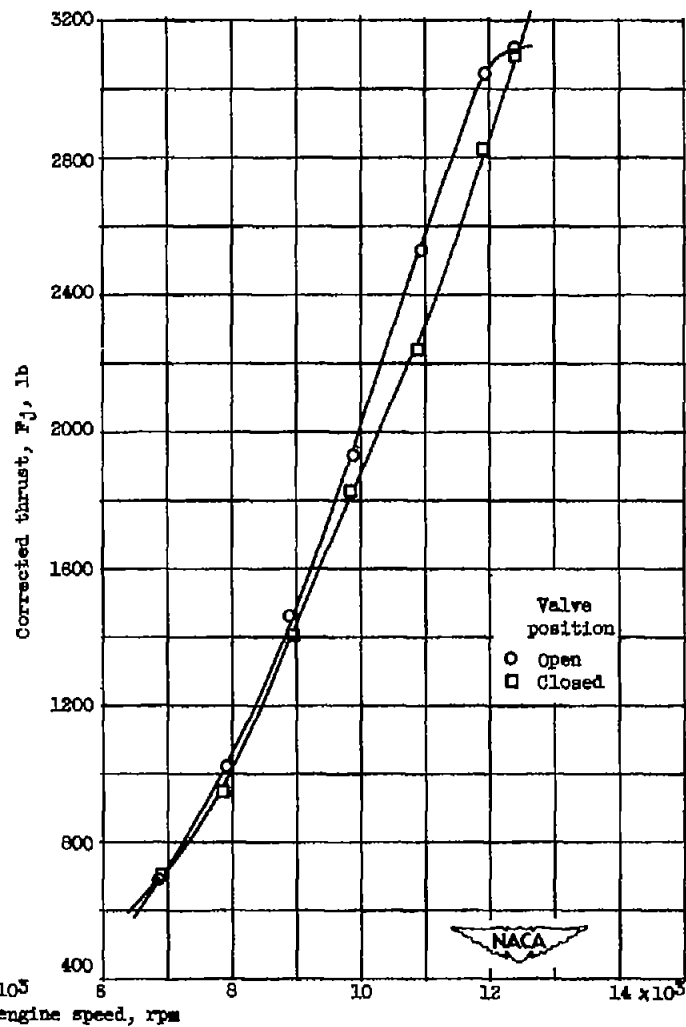
(a) Compressor efficiency.

(b) Pressure ratio.

Figure 5. - Effect of inlet-valve position on engine performance.

(c) Air flow.

(d) Engine thrust.

The valve position had a decided effect on engine performance. Figure 5 presents curves of the compressor efficiency, pressure ratio, and corrected air flow, and corrected engine thrust plotted against corrected engine speed. Operating with the closed valve reduced the corrected engine thrust approximately 9 percent. Such a loss in thrust would be serious; however, for the jet-engine installation with the twin-inlet-duct system the airplane could have one duct damaged or filled with foreign material during a flight with little or no effect on the ability of the airplane to return to its base.

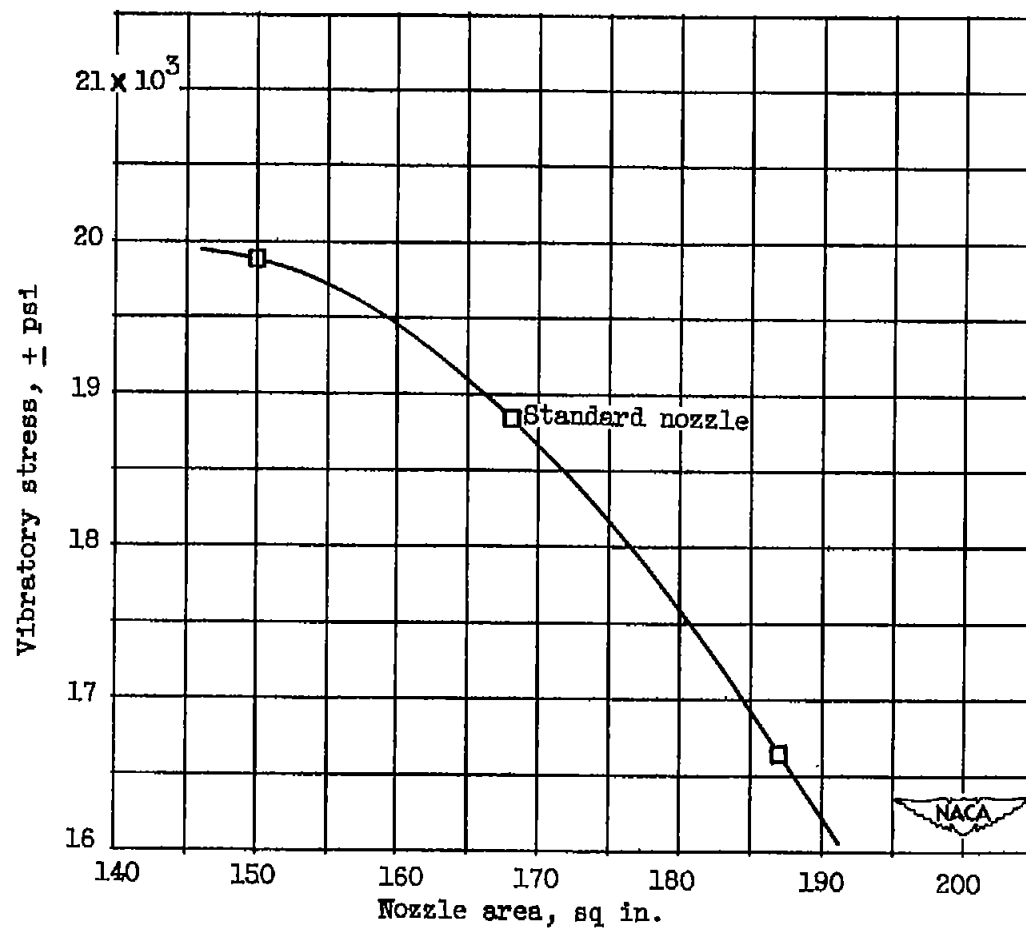
Figure 6. - Effect of exhaust-nozzle area on vibratory stress of third-stage blade.

Various exhaust nozzles. - The effect of exhaust-nozzle area on the third-stage blade vibration is presented in figure 6. As the nozzle area was reduced and the pressure ratio increased, the vibratory stress increased. This same effect was observed and reported in reference 1. The 168-square-inch nozzle was the standard for the investigation.

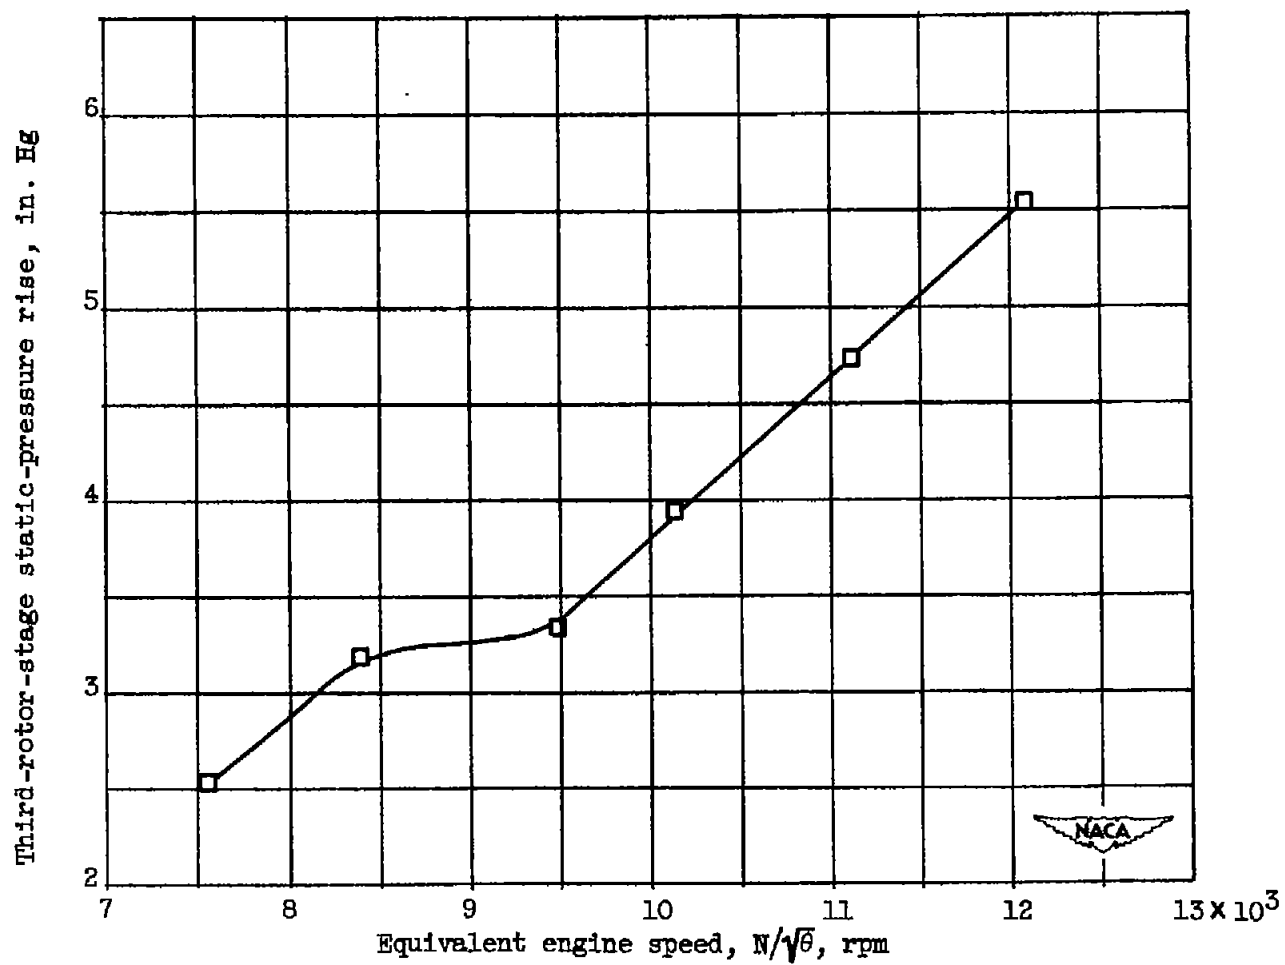
Figure 7. - Third-stage static-pressure-rise survey.

Pressure-rise test. - The third-stage static-pressure rise at equivalent engine speeds from 7500 to 12,000 rpm is shown in figure 7. A constant rate of pressure rise with engine speed was observed at all speeds except in the critical speed range from 8500 to 9500 rpm. Here the pressure remained approximately constant for about 1000 rpm, which indicated that the third stage was probably in a partially stalled condition.

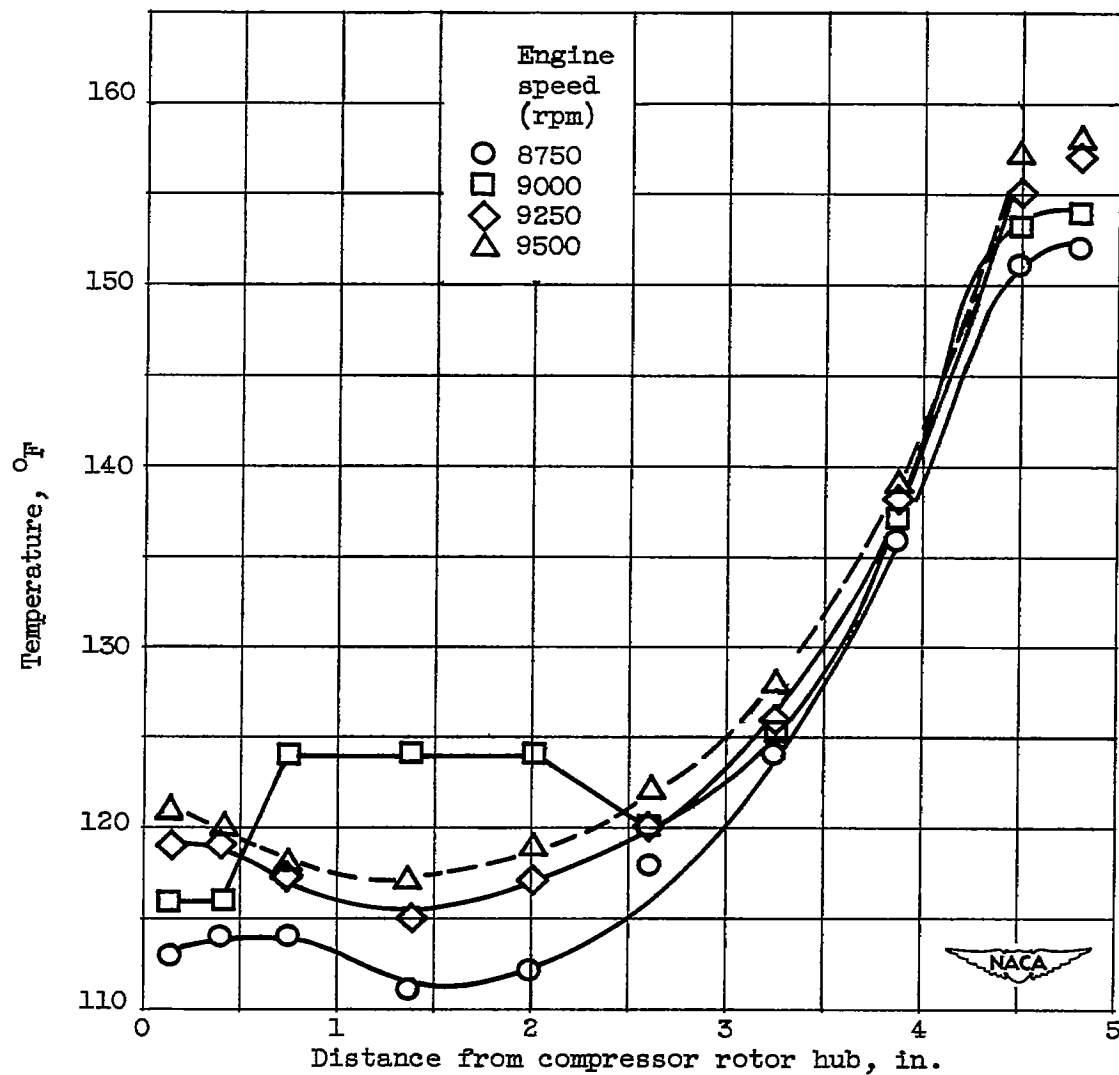
Figure 8. - Third-stage radial temperature survey.

Temperature and hot-wire measuring probes. - Data from the temperature survey of the air out of the third stage are plotted in figure 8. At all speeds the temperature increased uniformly from the base to the tip of the blade except from 1 to 2 inches from the hub at 9000 rpm. This 10° rise and the consistently high temperature at the blade tip indicate that stalling possibly exists around the lower part of the blade at 9000 rpm and at the tip throughout the complete critical speed range.

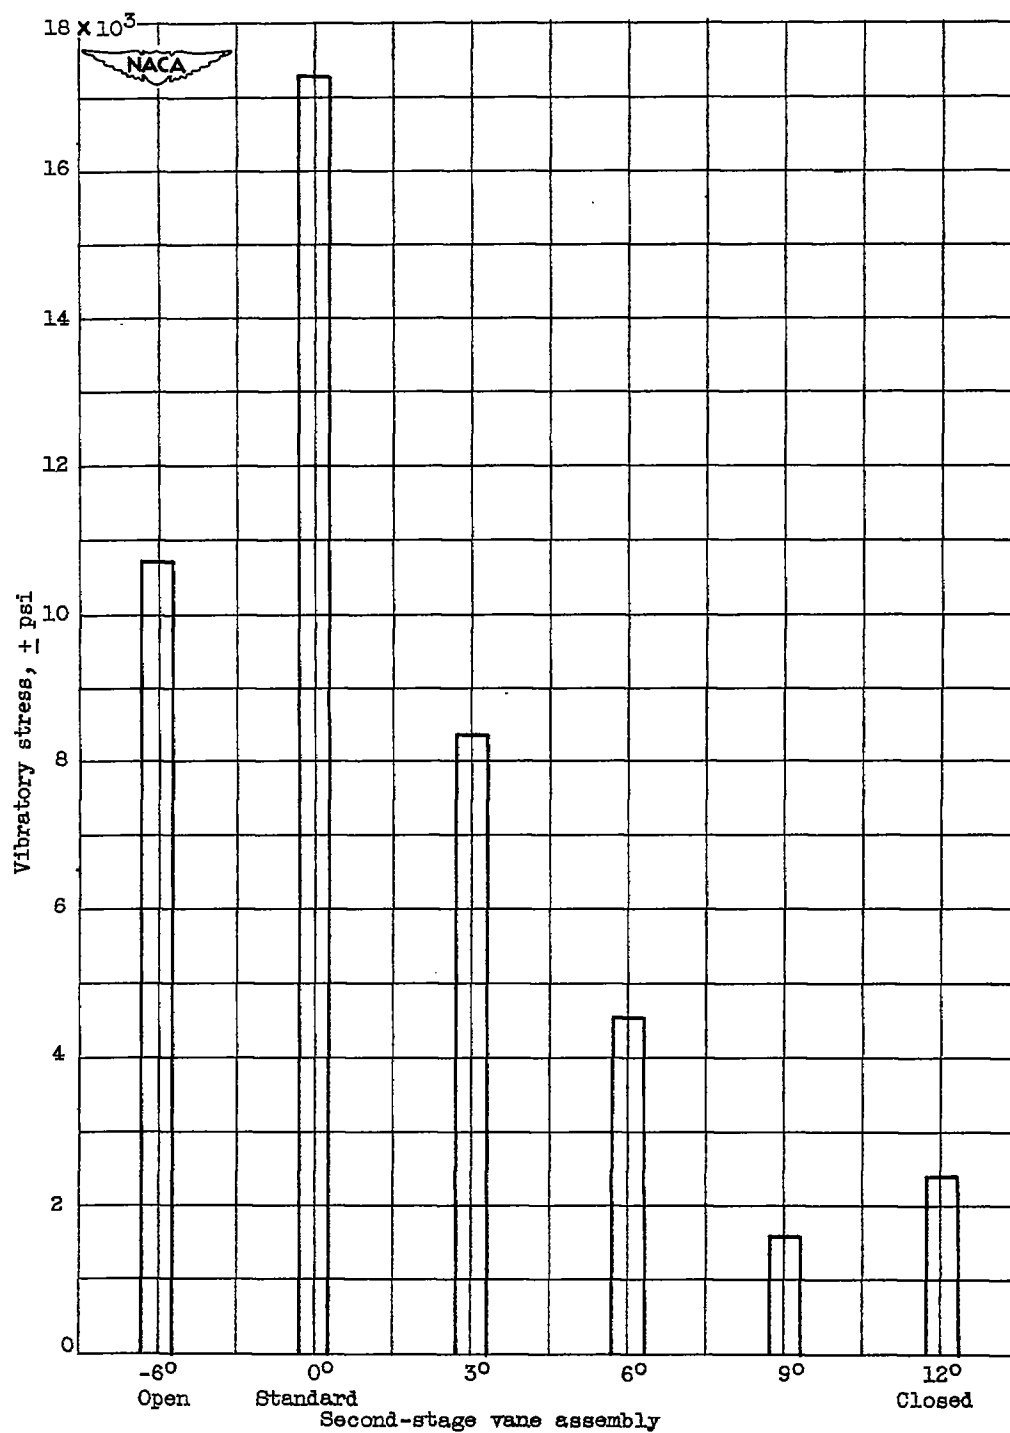
Figure 9. - Effect of second-stage vane-assembly angle of incidence on third-stage vibration.

Stator blades. - An investigation of the effect of the angle of incidence of the stator vanes immediately preceding the third stage of the compressor was conducted in a sea-level test stand; the results are shown in figure 9. The vibratory stress levels noted on this plot are averages of numerous data points of the maximum amplitude obtainable in the critical speed range for each stator angle. The number of stator assemblies tested for each angle, the resulting average stress, and the percentage of the stress produced by the standard vanes are presented in table I.

Installation of the stator with vanes closed 3° reduced the vibratory stress to less than half and would possibly bring the vibration below the danger point. A change, however, to 9° greater angle of incidence would assuredly eliminate all third-stage vibration failure of this compressor design in the critical speed range. However, with the 9° -closed

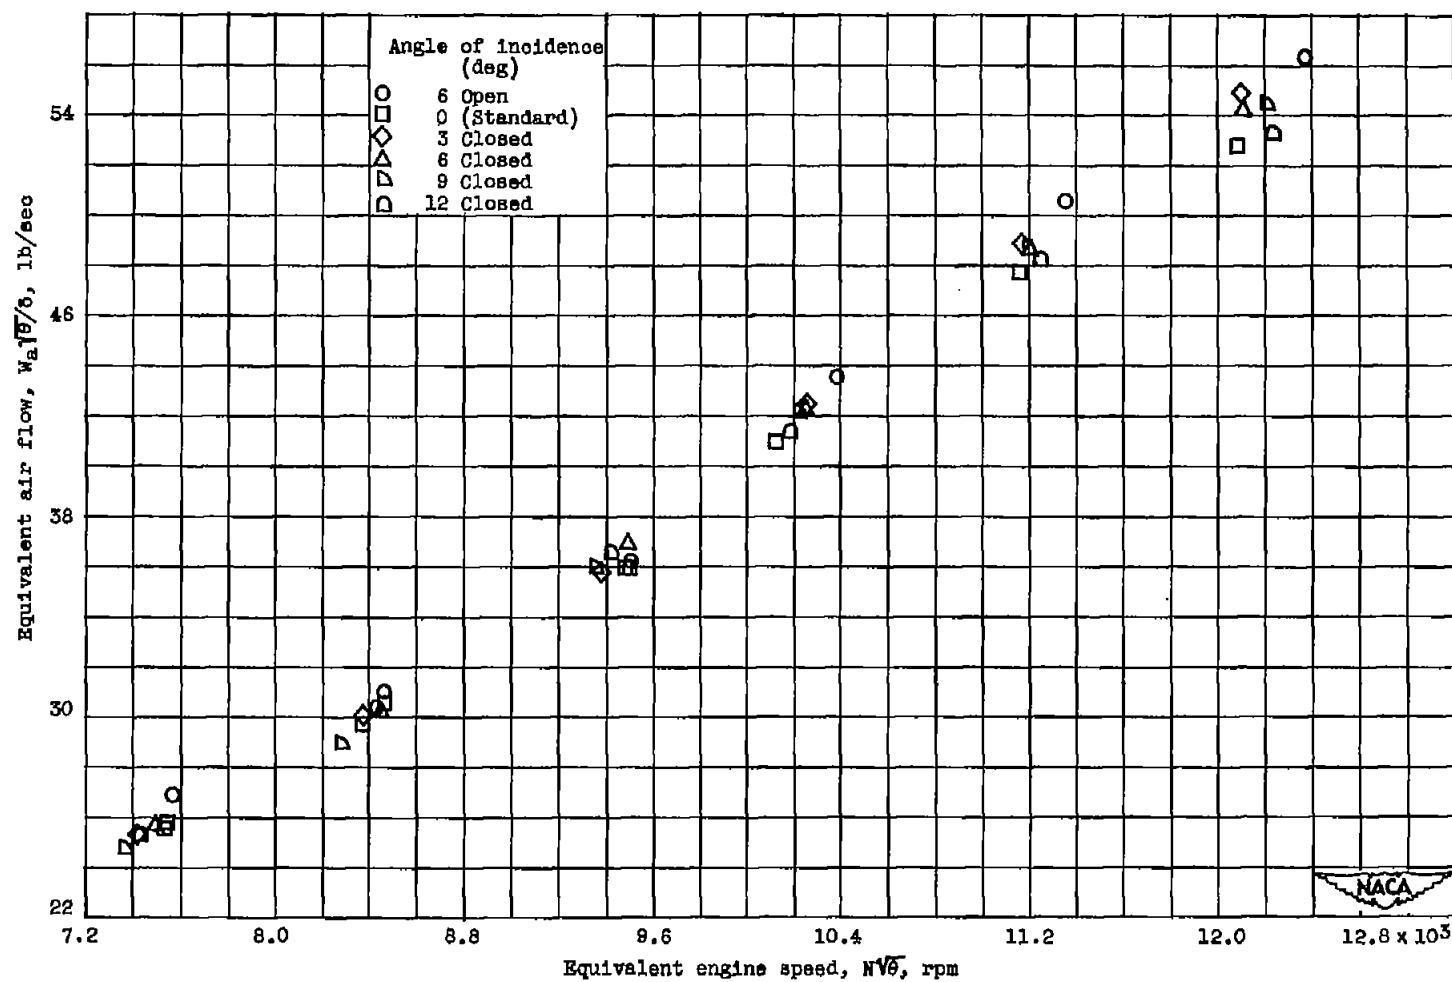
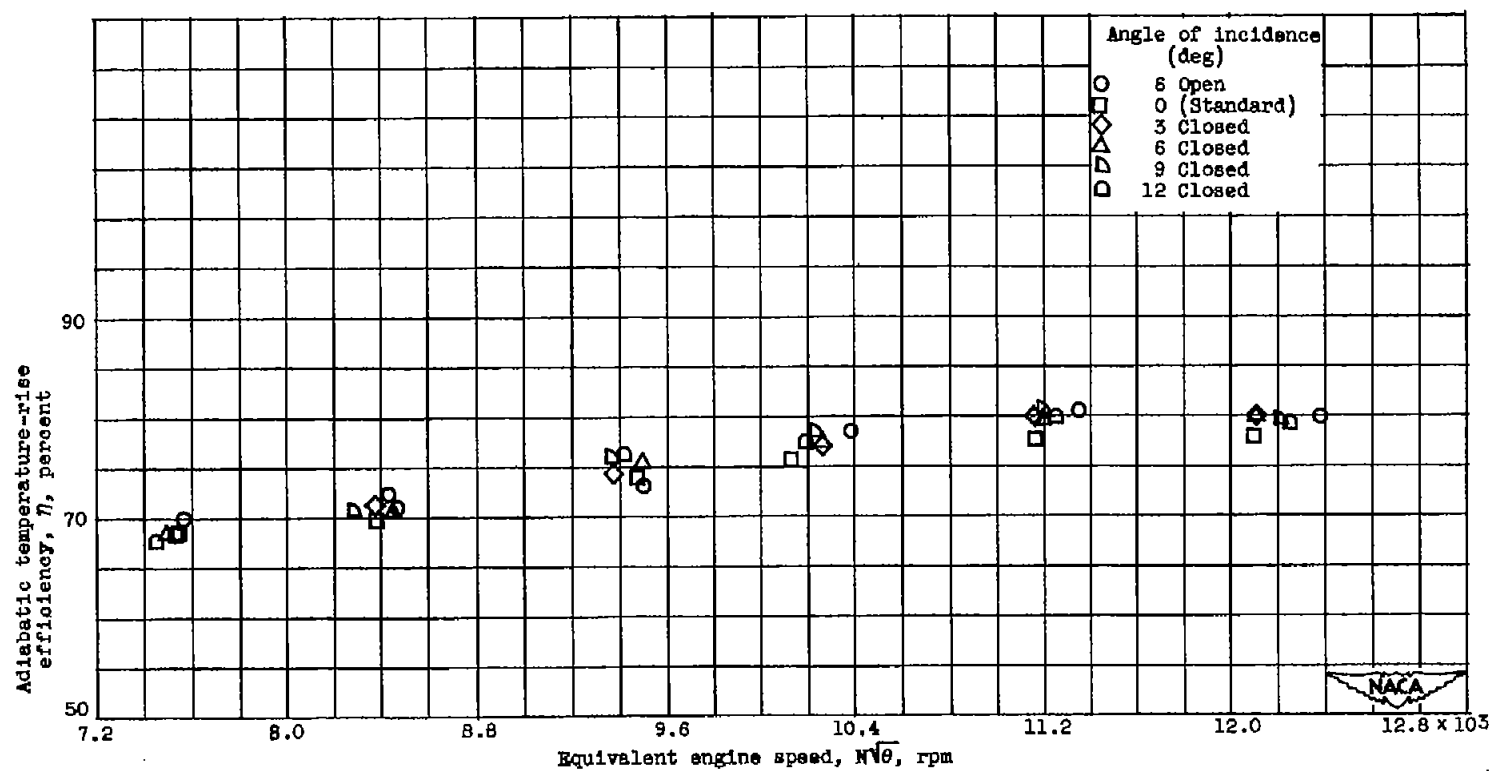
(a) Equivalent air flow.

Figure 10. - Performance characteristics of eleven-stage compressor with various second-stage vane-assembly angles of incidence.

(b) Adiabatic temperature-rise efficiency.

The complete speed range (to 12,500 rpm) was investigated with vanes of each angle to determine vibratory effects as well as engine performance. No new vibration of significant amplitude was introduced by any of the new angles. The effect on over-all engine performance is illustrated in figures 10 and 11. Although a total change of 18° (6° open to 12° closed) was investigated, very little change in engine performance was detected.

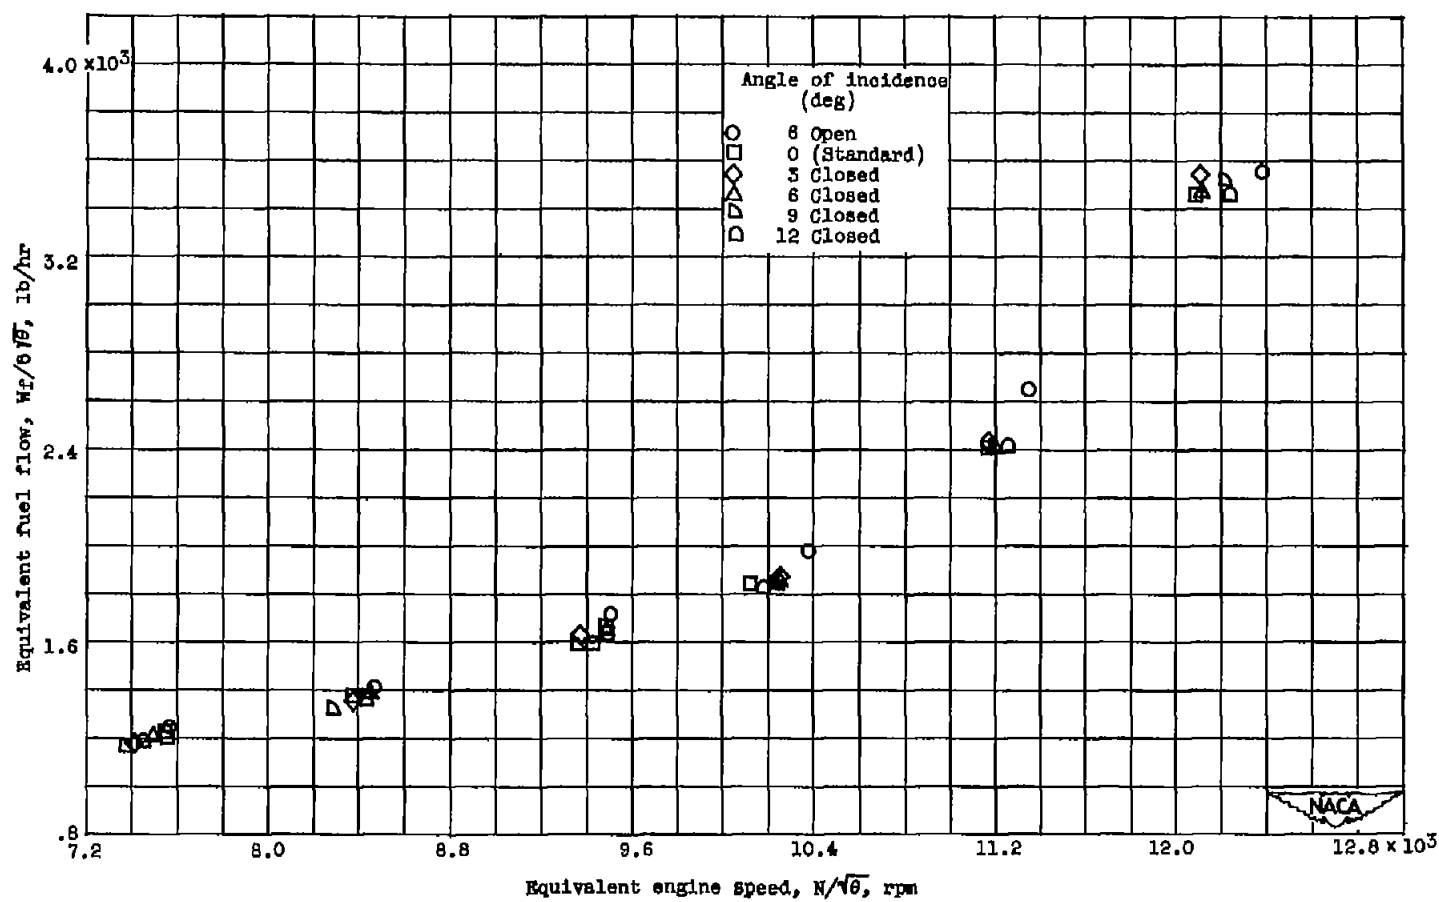
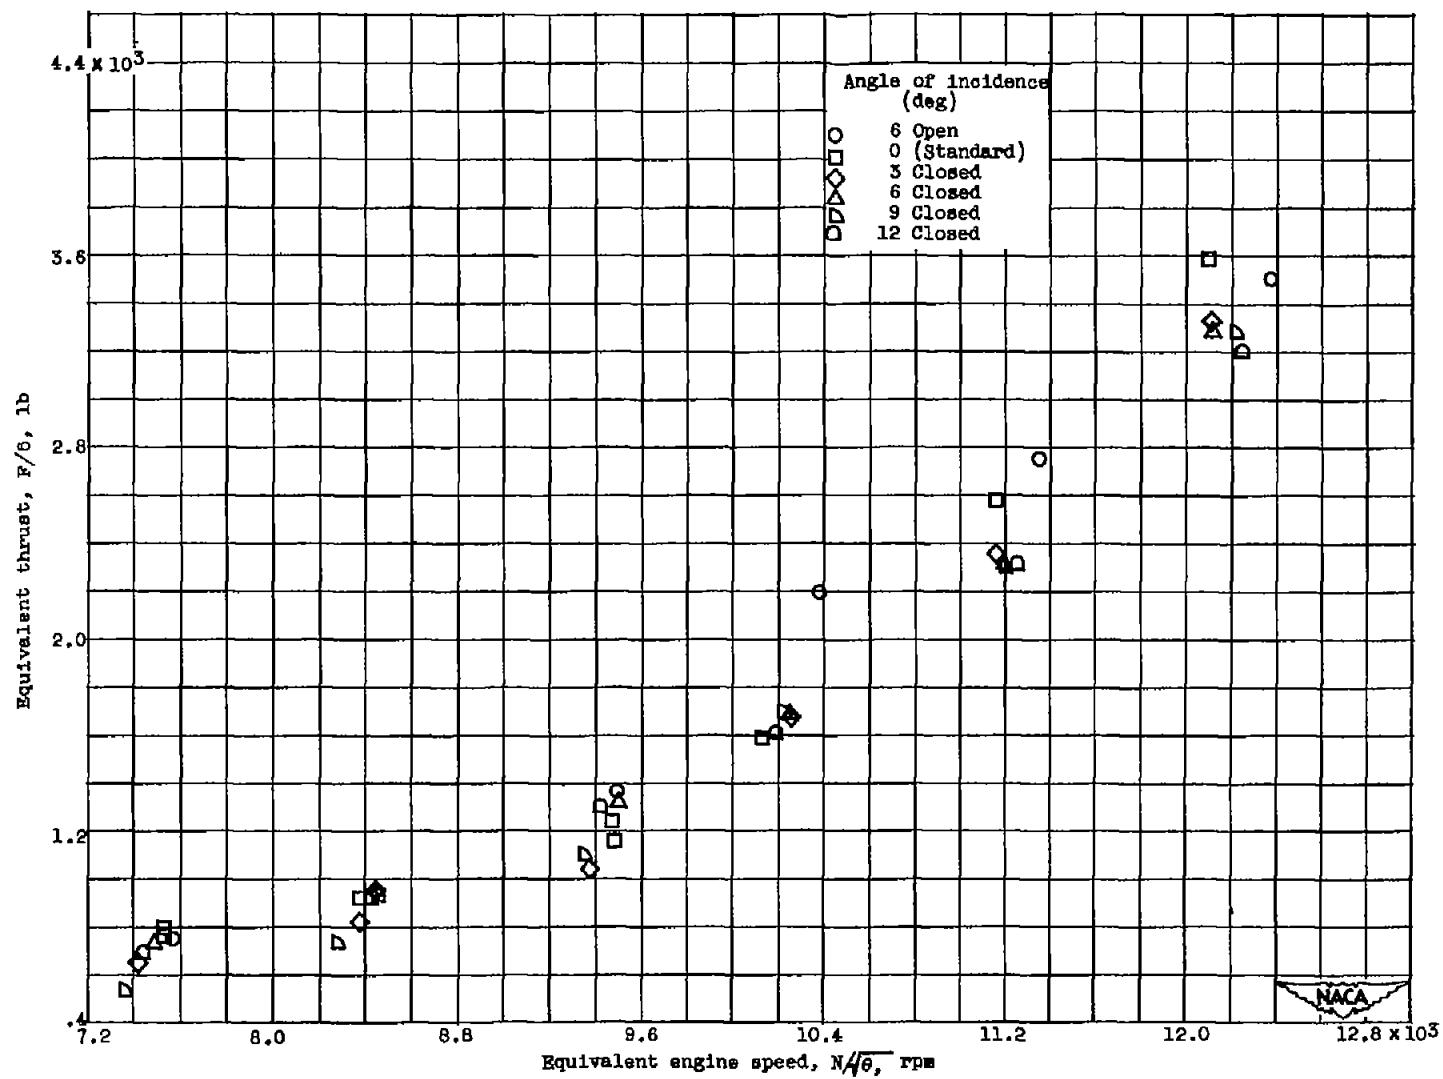
(a) Equivalent fuel flow.

Figure 11. - Performance characteristics of turbojet engine with various second-stage vane-assembly angles of incidence.

(b) Equivalent thrust.
